Permit Fact Sheet

Permit Number:	WI-0059528-05-0
Permittee Name:	Schmidts Ponderosa LLC
Address:	W3773 Old Dump Road
City/State/Zip:	Bonduel WI 54107
Discharge Location:	Main Dairy – W3773 Old Dump Road, Bonduel, WI 54107; NE ¼ Section 28, T26N, R17E Home Farm – N3170 Golden Lane, Bonduel, WI 54107; NE ¼ Section 28, T26N, R17E Bunker Site – N3070 S. Highline Road, Bonduel, WI 54107; SW ¼ Section 27, T26N, R17E

On Friday July 10, 2020 Hanson met with Schmidt, Schmidt, Nysse, Schuebel & Okkema at 13:00 at Schmidts Pondeosa Dairy site to conduct a permit reissuance walkover inspection. All three sites were inspected. No liquid precipitation had fallen recently and the temperature was in the 80's and sunny. No permit violations were observed, and no water samples were collected. Hanson departed at approximately 14:30.

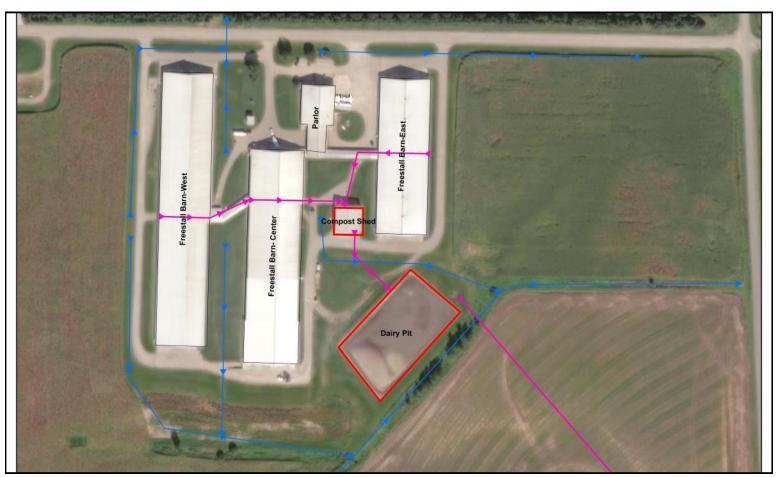
Site Overview Diagram (Main Dairy: orange lines = contaminated runoff, blue lines = stormwater flow, pink lines = waste transfer system)

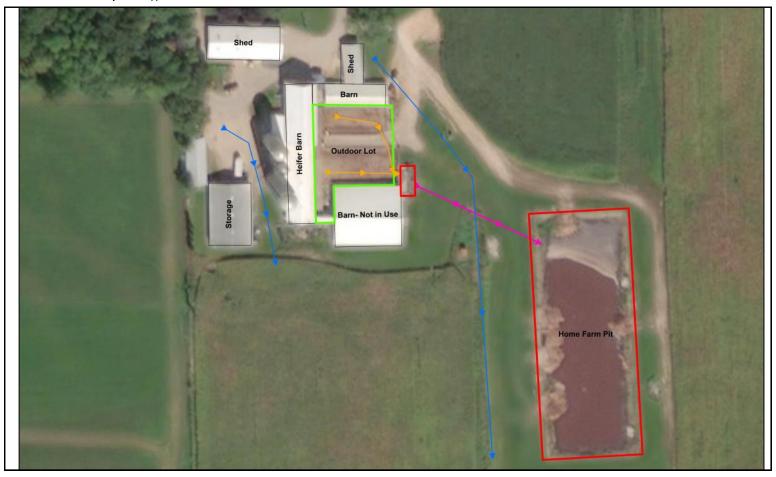
Site Overview Diagram (Home Farm: orange lines =contaminated runoff, blue lines= stormwater flow, pink lines= waste transfer system))

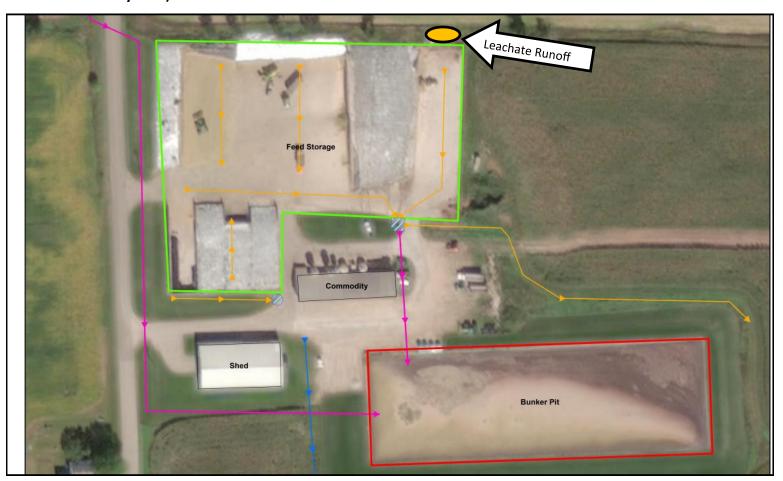
Site Overview Diagram (Bunker Site: orange lines =contaminated runoff, blue lines= stormwater flow, pink lines= waste transfer system)

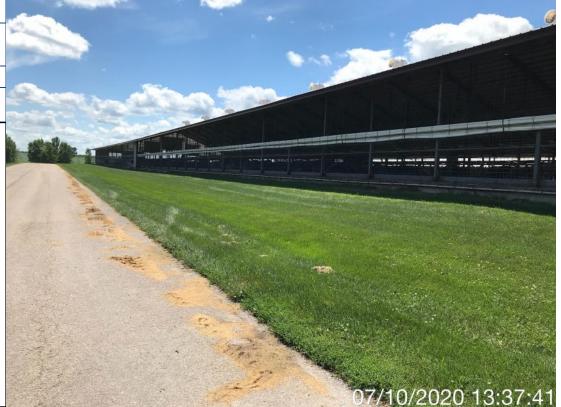
Photo #:	1077
Date/Time of Photo:	7/10/2020 13:37
Photo By:	Brian Hanson
Photo Location:	Main Dairy

Looking south. View of storm water channel on east side of freestall barns.

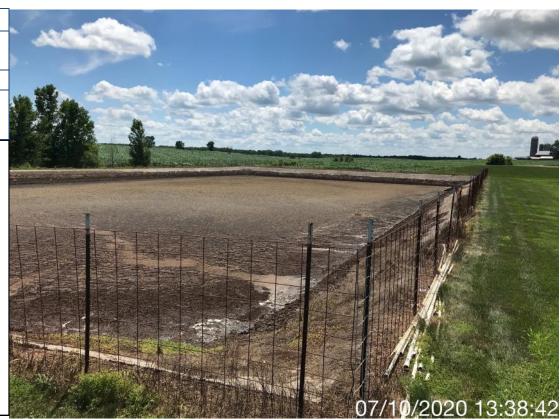
Photo #:	1078
Date/Time of Photo:	7/10/2020 13:38
Photo By:	Brian Hanson
Photo	Main Dairy

Standing at NE corner of WSF #2, looking West.: View of WSF #2, sample point 3. Manure pit in good condition with proper safety fence installed

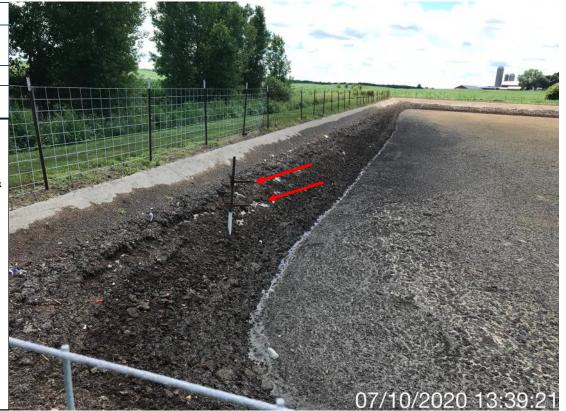
Photo #:	1082
Date/Time of Photo:	7/10/2020 13:39
Photo By:	Brian Hanson
Photo	Main Dairy
Location:

Standing at SE corner of WSF #2, looking West: View of Mol & MOS markers in WSF at Main Dairy. Red arrows point to the level indicators.

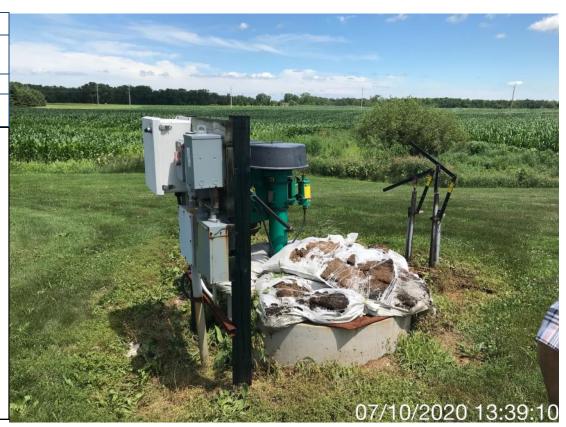
Photo #:	1080
Date/Time of Photo:	7/10/2020 13:39
Photo By:	Brian Hanson
Photo Location:	Main Dairy

Looking East: View of waste transfer system on east end of WSF at the Main Dairy. The farm uses this transfer system to pump manure from main dairy to manure storage at Bunker site. This is manually controlled every few weeks as needed.

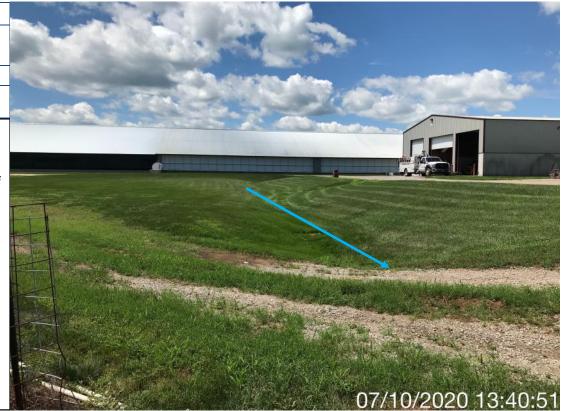
Photo #:	1087
Date/Time of Photo:	7/10/2020
Photo By:	Brian Hanson
Photo Location:	Main Dairy

Looking West: View of storm water flow path on north side of WSF at main dairy. Arrow indicates flow direction.

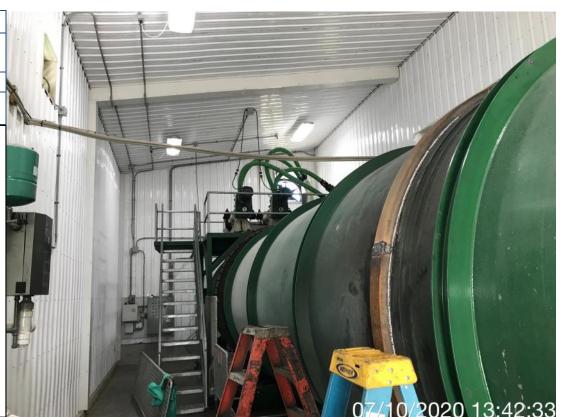
Photo #:	1093
Date/Time of Photo:	7/10/2020 13:42
Photo By:	Brian Hanson
Photo	Main Dairy
Location:

View of inside the west half of the solids separation building. Manure is put through a series of solids separators. Liquids are pumped to waste storage.. Manure solids are run through the composting drum and stored in east half of the building until they are used as bedding.

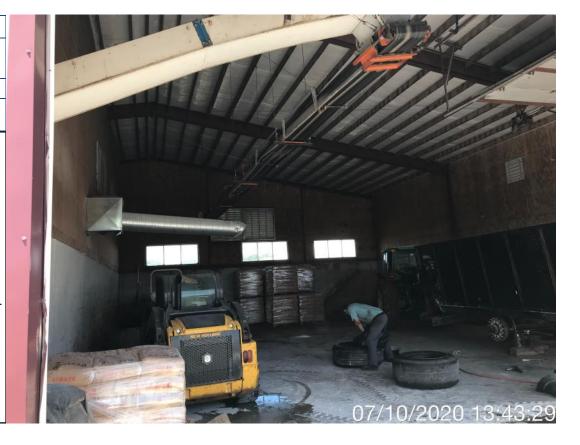
Photo #:	1100
Date/Time of Photo:	7/10/2020 13:43
Photo By:	Brian Hanson
Photo	Main Dairy
Location:

View of the east half of the solid separation building. This area is typically used to store the bedding solids until they are used in the barns. Composting drum was currently down for repairs so no bedding had been produced for a few day. Only a small pile remained in far corner of building.

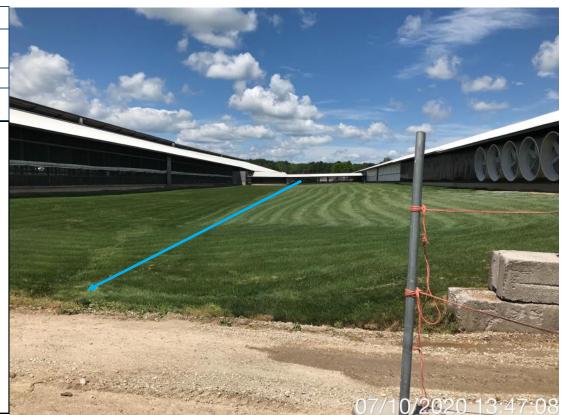
Photo #:	1111
Date/Time of Photo:	7/10/2020 13:47
Photo By:	Brian Hanson
Photo	Main Dairy
Location:

Looking North: View of storm water channel in between freestall barns. Arrow indicates direction of flow.

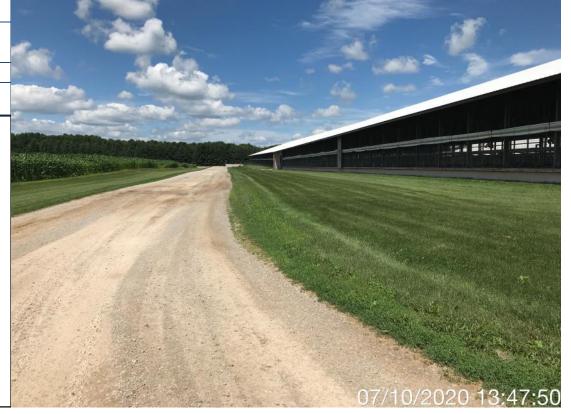
1115
7/10/2020 13:47
Brian Hanson
Main Dairy

Looking North: View of storm water channel on west side of freestall barns.

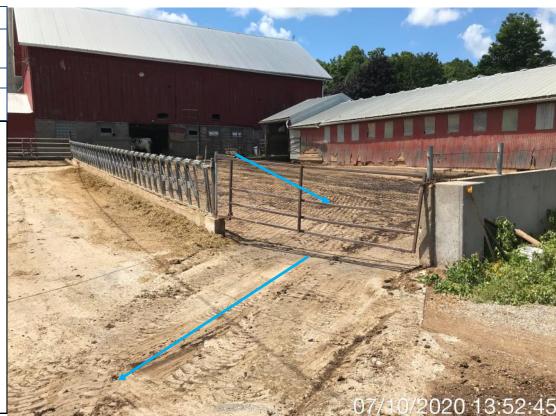
Photo #:	1119
Date/Time of Photo:	7/10/2020 13:52
Photo By:	Brian Hanson
Photo	Home Farm
Location:

Looking Northwest: View of outdoor feedlot at home farm for heifers/steers. Runoff flows southeast to a reception tank at edge of yard. Arrows indicate direction of flow.

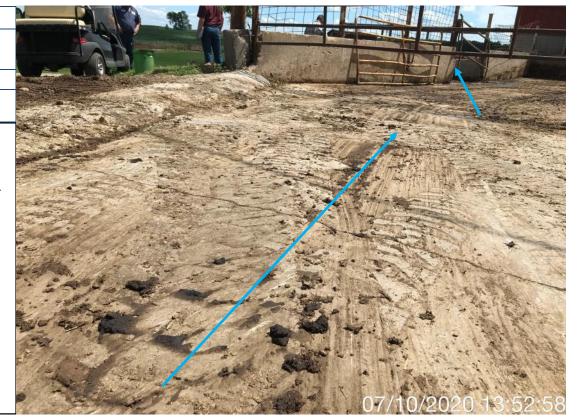
Photo #:	1121
Date/Time of Photo:	7/10/2020 13:52
Photo By:	Brian Hanson
Photo	Home Farm
Location:

Looking Southeast: View of outdoor feedlot runoff controls. Notice curb on left side of lot. To contain runoff Arrows indicate direction of flow.

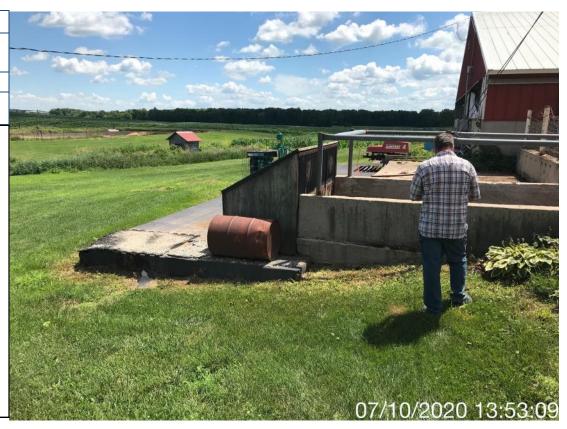
Photo #:	1122
Date/Time of Photo:	7/10/2020 13:53
Photo By:	Brian Hanson
Photo Location:	Home Farm
Location.

Looking South: View of reception tank and pump on east end of outdoor feedlot.
Manure & lot runoff is pumped to WSF at home farm located in the background.

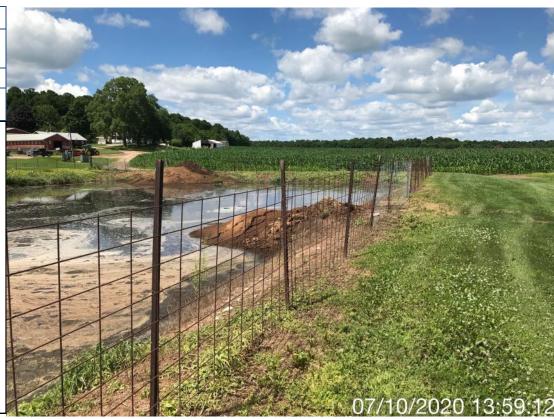
Photo #:	1138
Date/Time of Photo:	7/10/2020 13:59
Photo By:	Brian Hanson
Photo	Home Farm
Location:

Looking North: View of WSF #1 at home farm also known as sample point 001 in permit. Earthen facility that was constructed in 1993. This storage receives manure and runoff from outdoor feedlot as well as solid manure from barns onsite..

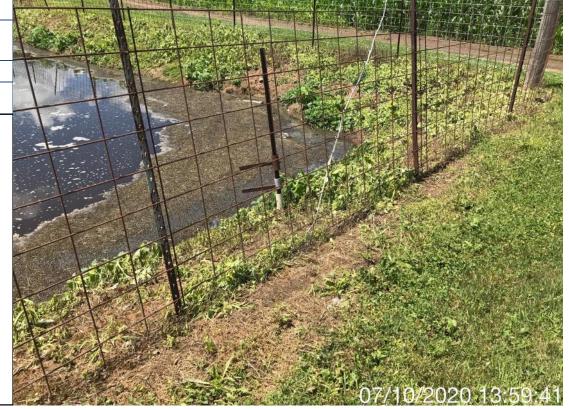
Photo #:	1139
Date/Time of Photo:	7/10/2020 13:59
Photo By:	Brian Hanson
Photo	Home Farm
Location:	
Photo Deceription

Looking Northwest & down: View of MOL & MOS marker in WSF at home farm.

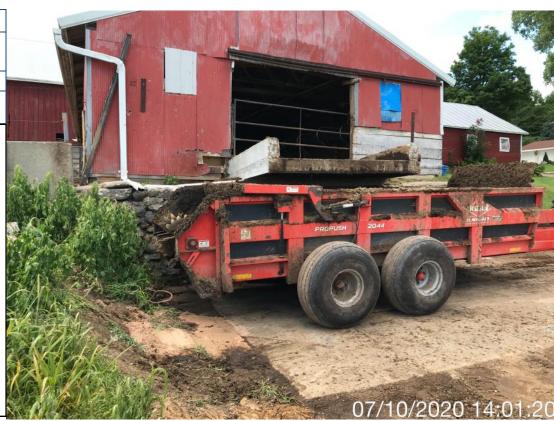
Photo #:	1141
Date/Time of Photo:	7/10/2020 14:01
Photo By:	Brian Hanson
Photo	Home Farm
Location:

Looking West: View of barn on north side of outdoor lot. Manure is manually scraped into spreader on east end of barn. Manure is then either land applied or transferred into WSF onsite.

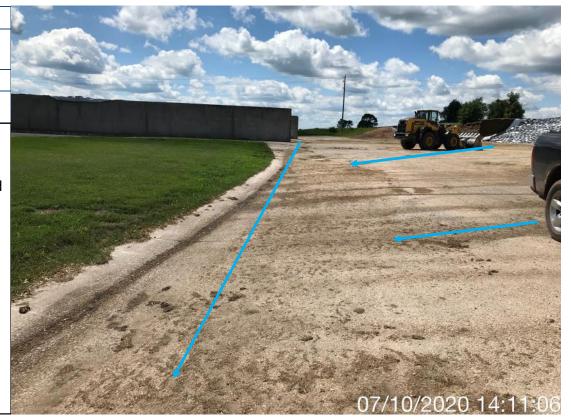
Photo #:	1156
Date/Time of Photo:	7/10/2020 14:11
Photo By:	Brian Hanson
Photo Location:	Bunker Site

Standing at leachate collection tank looking West: View of feed storage area runoff controls. Arrows indicate direction of flow.

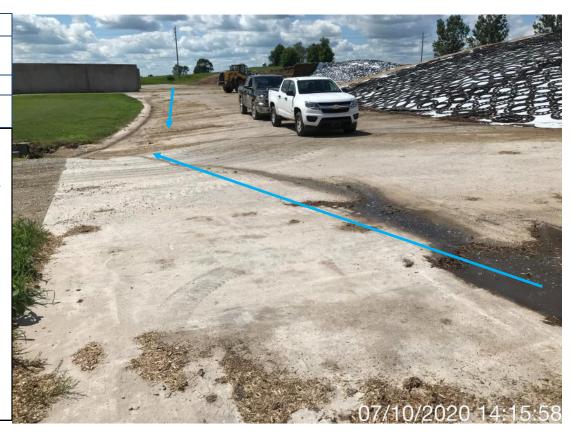
Photo #:	1166
Date/Time of Photo:	7/10/2020 14:15
Photo By:	Brian Hanson
Photo	Bunker Site
Location:

Standing at SE corner of feedpad looking West: View of feedpad runoff collection system. Arrows indicate direction of flow.

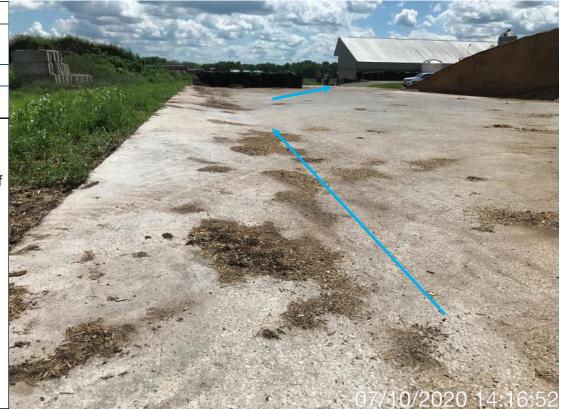
Photo #:	1169
Date/Time of Photo:	7/10/2020 14:16
Photo By:	Brian Hanson
Photo Location:	Bunker Site

Standing at NE corner of feedpad looking South: View of feedpad runoff collection system. Arrows indicate direction of flow

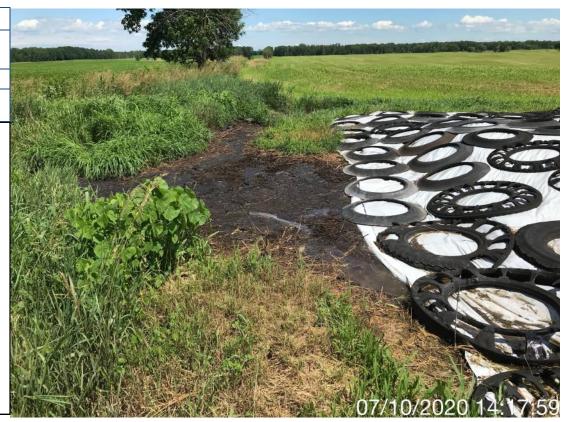
Photo #:	1172
Date/Time of Photo:	7/10/2020 14:17
Photo By:	Brian Hanson
Photo Location:	Bunker Site

There was also a small area of ponded leachate in the northeast corner of the feedpad that appeared to have flowed off of the feedpad and into a nearby grassy area. This most likely occurred from a combination of improper drainage of stormwater being allowed to enter the feedpad at this location & the feed pile extending beyond the edge of the feedpad slightly. See photo 1172. The farm should immediately clean up the leachate and correct the drainage issues in this area to prevent future occurrences.

Standing on north end of feedpad looking East: View of small area of leachate & runoff that is ponded adjacent to the feed storage area.

- Small area of leachate on northeast corner of feedpad needs to be cleaned up and drainage corrected to prevent this from happening in the future.
- South side of bunker walls appear to be deteriorating and maintenance of the these wall should occur to reduce the chance of leachate from leaving the feedpad

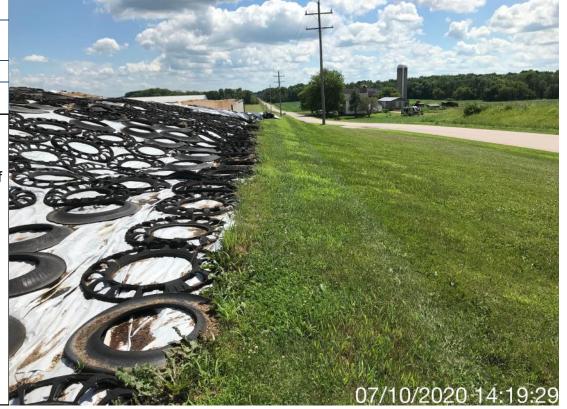
Photo #:	1178
Date/Time of Photo:	7/10/2020 14:19
Photo By:	Brian Hanson
Photo Location:	Bunker Site

Standing at NW corner of feedpad looking South/: View of western edge of feedpad. Runoff controls not visible, but no sign of leachate or runoff leaving the pad.

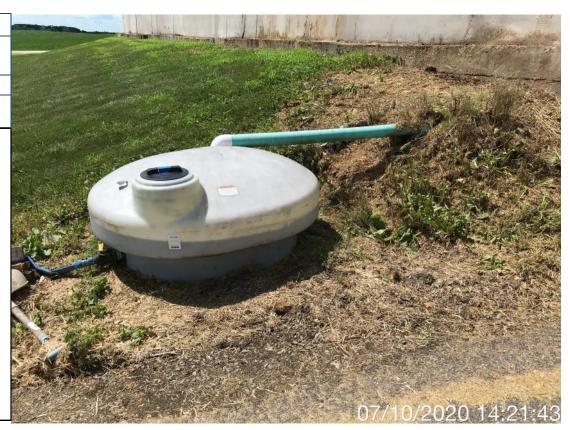
Photo #:	1185
Date/Time of Photo:	7/10/2020 14:21
Photo By:	Brian Hanson
Photo	Bunker Site
Location:

The south side of the bunker walls appeared to be starting to deteriorate and had multiple cracks where leachate was present along the wall footing. A tile drain system is present along this section of wall and appeared to collecting leachate into a plastic reception tank. See photo 1185. The farm should continue to monitor this area for possible runoff and consider further maintenance of these bunker walls to prevent possible future discharges.

Standing on south side of feed bunkers looking west: View of leachate collection tank. Tile along southern edge of old bunkers collects any leachate via a tile drain system. Tank is then drained into payloader bucket via blue hose and transferred to WSF onsite.

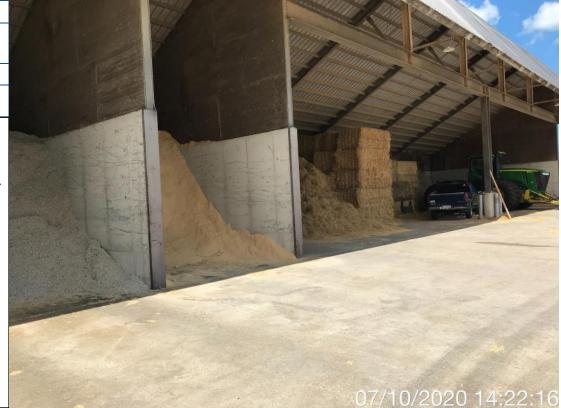
Photo #:	1189
Date/Time of Photo:	7/10/2020 14:22
Photo By:	Brian Hanson
Photo Location:	Bunker Site

Looking northeast: View of Commodity shed at bunker site. All feed is under roof and no signs of any runoff is present.

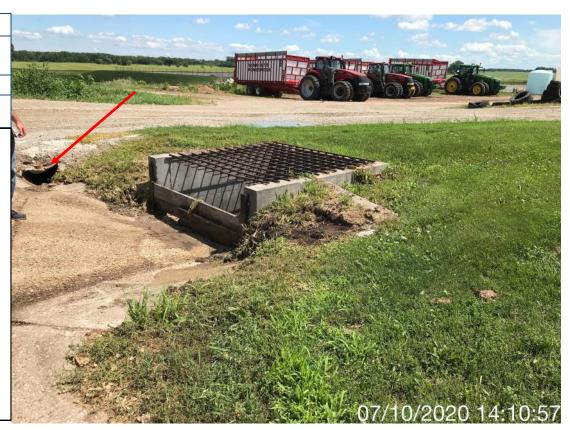
Photo #:	1154
Date/Time of Photo:	7/10/2020 14:10
Photo By:	Brian Hanson
Photo Location:	Bunker Site
Location:

Standing at SE corner of feeedpad looking Southeast: View of leachate runoff collection system. Arrow pointing to culvert that accepts overflow runoff and transfers it to a concentrated flow channel and crop field.

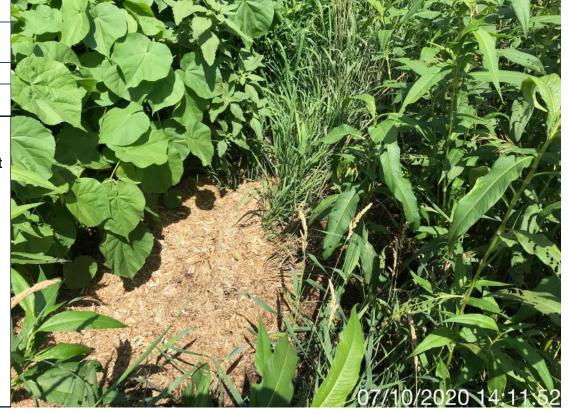
Photo #:	1159
Date/Time of Photo:	7/10/2020 14:11
Photo By:	Brian Hanson
Photo Location:	Bunker Site

All feed storage areas and runoff controls are located at the Bunker Site. Surface drainage of leachate and runoff is directed to a centralized collection point which gravity flows to the Bunker Pit. A series of stop logs direct the first flush into the system and the remaining runoff overflows through a culvert into the nearby field via a concentrated flow channel. The concentrated flow channel was well vegetated and showed no signs of burnt vegetation, however there were a few spots showing accumulated feed solids in the channel. See photos 1154 & 1159. Schmidts Pondersa should continue to keep feedpad clean or remove additional stop logs to reduce the chances of feed solids from entering the overflow channel.

Standing on east side of culvert that accepts overflow runoff from feed storage area, looking down: View of accumulated feed solids that have left the feed storage area and settled out in concentrated flow channel.

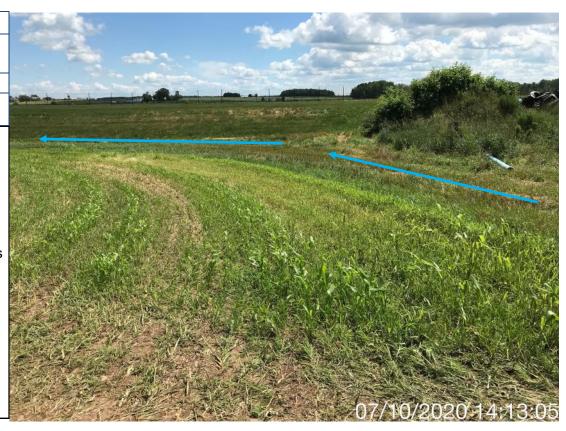
Photo #:	1163
Date/Time of Photo:	7/10/2020 14:13
Photo By:	Brian Hanson
Photo Location:	Bunker Site

Standing on east side of feed storage area looking south towards WSF.: view of concentrated flow channel for overflow from feed storage runoff collection system. Arrows indicate direction of flow. Vegetation was prevalent & showed no sign of excess nutrients in this area.

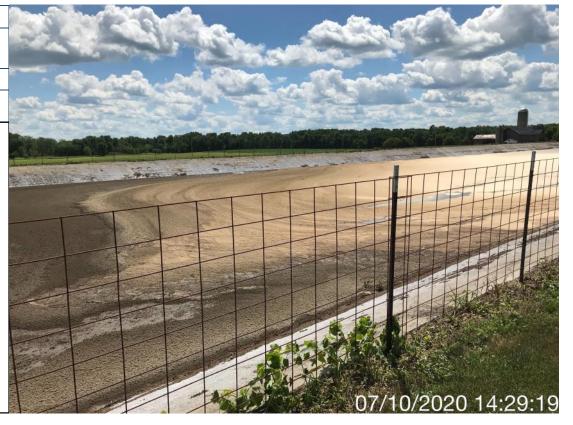
Photo #:	1204
Date/Time of Photo:	7/10/2020 14:29
Photo By:	Brian Hanson
Photo Location:	Bunker Site

Standing at NE corner of WSF looking Southwest: View of WSF at bunker site.

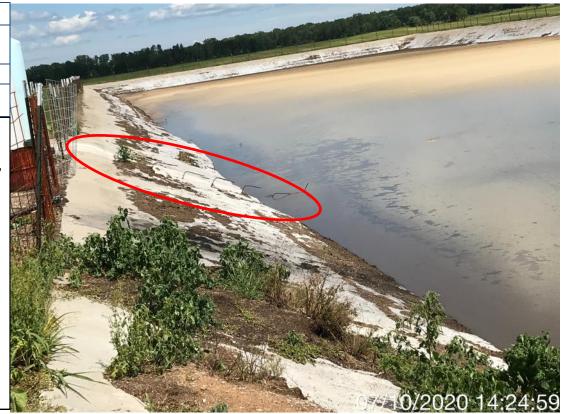
Photo #:	1193
Date/Time of Photo:	7/10/2020 14:24
Photo By:	Brian Hanson
Photo Location:	Bunker Site

Standing at NW corner of WSF, looking east: View of marker system in WSF to calculate volumes and indicate useable depths.
